ARBORIST REPORT

**PLACER COUNTY LAND DEVELOPMENT BUILDING
DEWITT CENTER, AUBURN, CA**

**Hideo Ray Yamasaki, ASLA
Certified Arborist #WC-1036
Yamasaki Landscape Architecture
Dated: September 17, 2002**

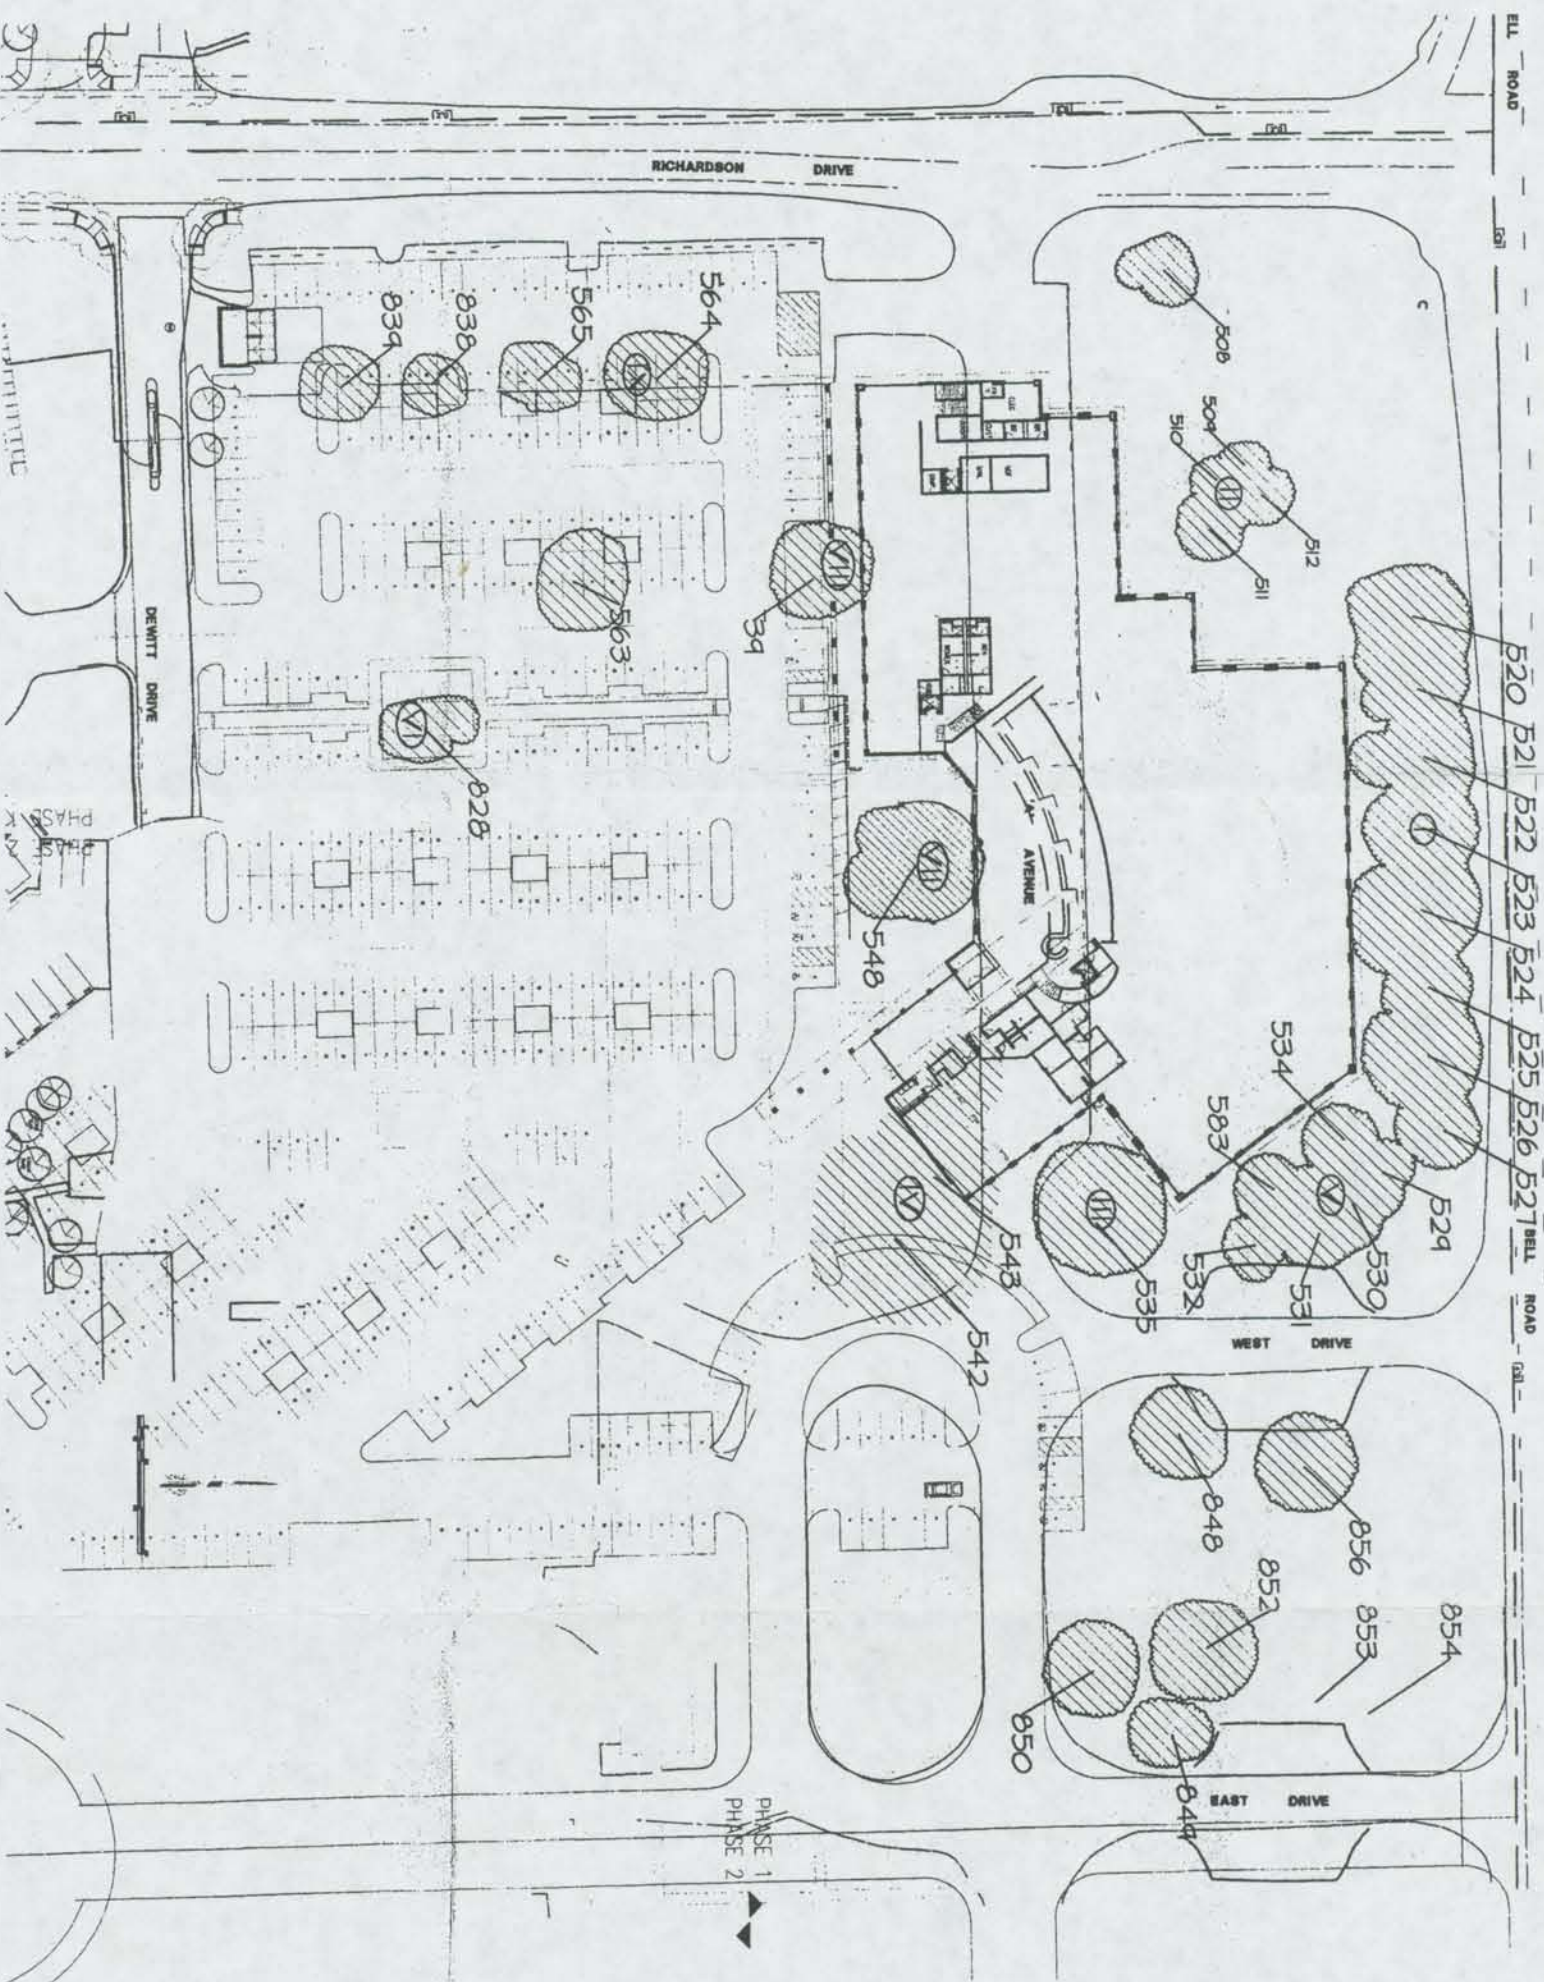
TREE # 34	Platanus acerifolia - Oriental Plane
TREE # 306	Pinus virginiana
TREE # 504	Sequoiadendron giganteum - Giant Sequoia
TREE # 510	Sequoiadendron giganteum - Giant Sequoia
TREE # 511	Sequoiadendron giganteum - Giant Sequoia
TREE # 512	Sequoiadendron giganteum - Giant Sequoia
TREE # 520	Acer saccharum - Silver Maple
TREE # 521	Acer saccharum - Silver Maple
TREE # 522	Acer saccharum - Silver Maple
TREE # 523	Acer saccharum - Silver Maple
TREE # 524	Acer saccharum - Silver Maple
TREE # 525	Acer saccharum - Silver Maple
TREE # 526	Acer saccharum - Silver Maple
TREE # 527	Acer saccharum - Silver Maple
TREE # 528	Acer saccharum - Silver Maple
TREE # 529	Liquidambar styraciflua - Sweet Gum
TREE # 530	Liquidambar styraciflua - Sweet Gum
TREE # 531	Liquidambar styraciflua - Sweet Gum
TREE # 532	Liquidambar styraciflua - Sweet Gum
TREE # 533	Liquidambar styraciflua - Sweet Gum
TREE # 534	Liquidambar styraciflua - Sweet Gum

TREE # 542	Quercus douglasii - Blue Oak
TREE # 543	Quercus douglasii - Blue Oak
TREE # 548	Acer saccharum - Silver Maple
TREE # 563	Ulmus parvifolia - Chinese Elm
TREE # 575	Cupressus glabra - Arizona Cypress
TREE # 828	Quercus ruber - Cork Oak
TREE # 848	Chimonium camphora - Camphor Tree
TREE # 849	Chimonium camphora - Camphor Tree
TREE # 850	Chimonium camphora - Camphor Tree
TREE # 856	Chimonium camphora - Camphor Tree
TREE # 903/535	Quercus douglasii - Blue Oak

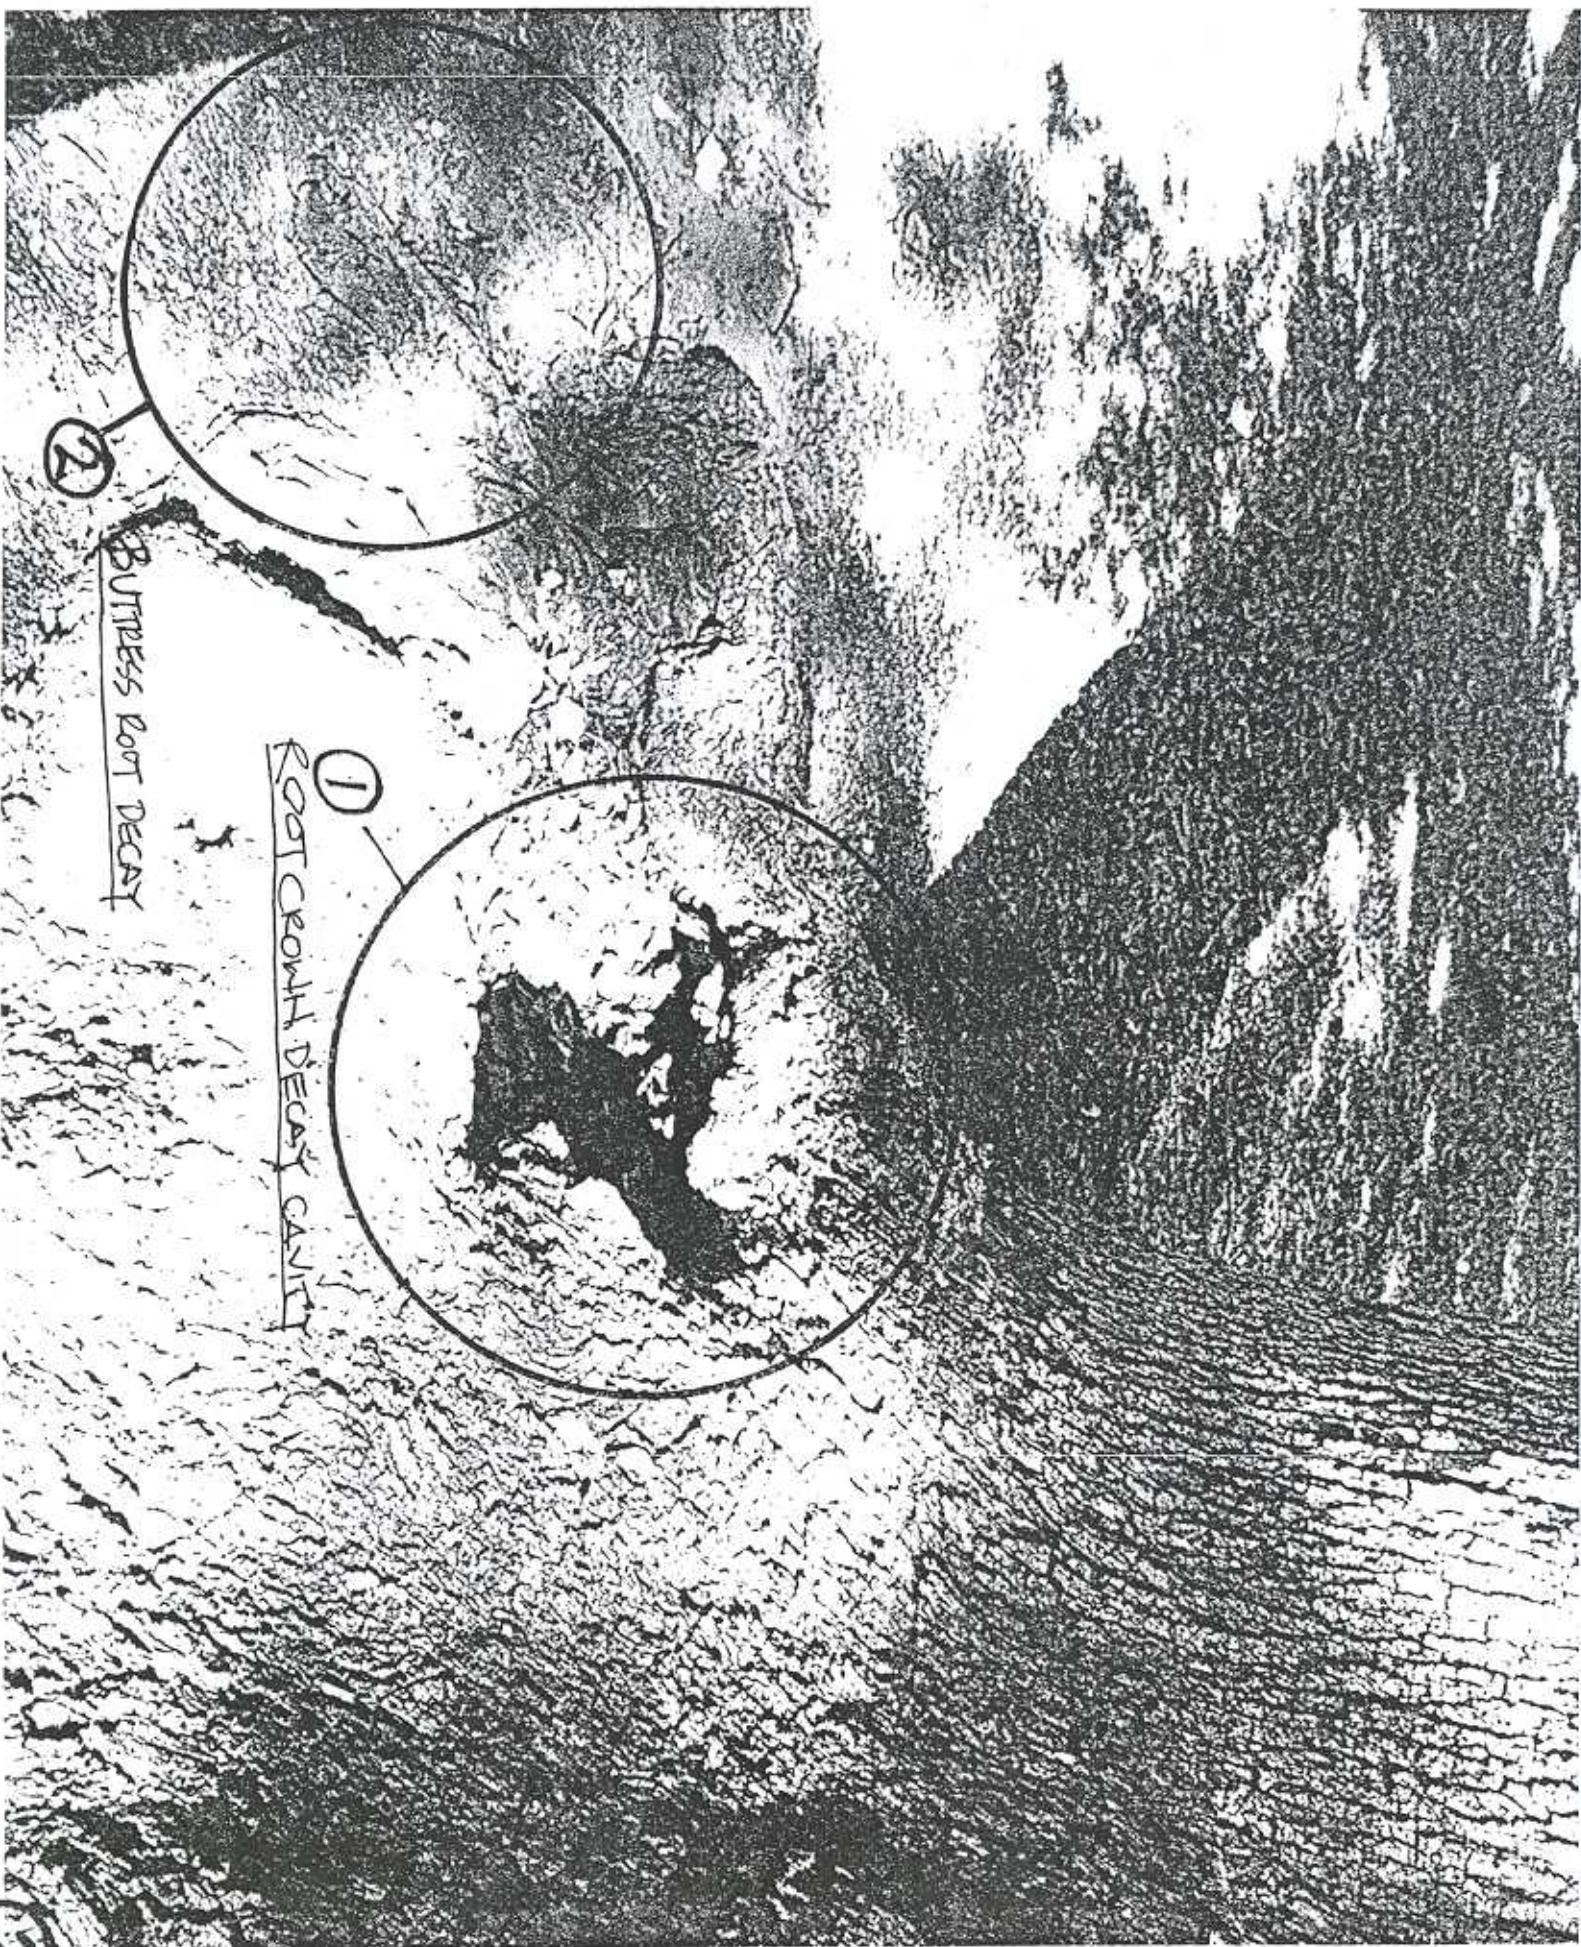
As noted in Bob Henwood study thickness of sound wood in the trunk is as little as 6" because of the Root Crown decay cavity.

① ROOT CROWN AND
TRUNK DECAY AND
CAVITY

In view of the extensive construction activity proposed in the vicinity, and the over all structure health and prognosis for longevity, It is recommended that this tree be removed due to Root Crown decay.
